DDASaccident720

DDAS Accident Report

Report date: 08/07/2011	Accident number: 720
Accident time: 10:29	Accident Date: 21/03/2011
Where it occurred: Sabha 11/(384), Kum Al Ruff Village, Mafrq Province, Sector East	Country: Jordan
Primary cause: Field control inadequacy (?)	Secondary cause: Unavoidable (?)
Class: Excavation accident	Date of main report: None
ID original source: None	Name of source: Demining group
Organisation: [Name removed]	
Mine/device: M14 AP blast	Ground condition: dry/dusty grass/grazing area rocks/stones
Date record created:	Date last modified: 08/07/2011
No of victims: 1	No of documents: 2

Incident investigation for [Demining group] – Mine Action Team – Jordan

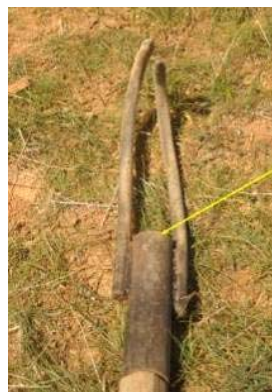
13. List any mine action equipment or property damage: Heavy Rake, Damaged (Not Reusable)

The damaged Heavy rake
